CESO 2019

MEDICAL IMAGING CT PROBLEMS/CASE STUDY

CT DETECTOR ARTIFACT ANALYSIS

BY DOUG MCTAGGART/ADAM DEBEBE

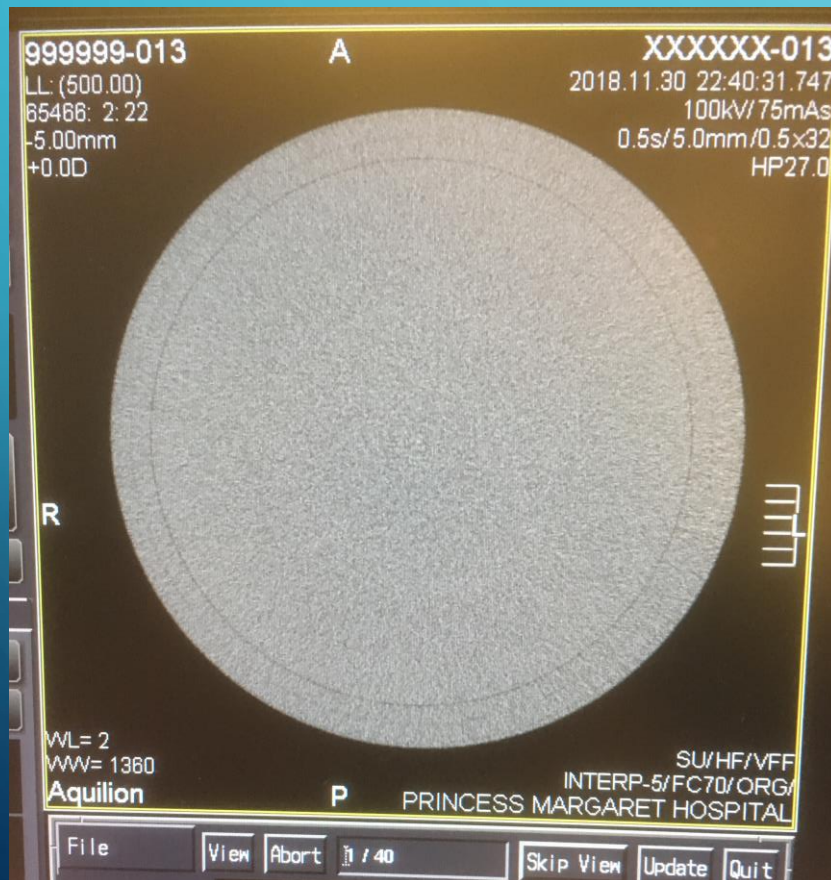
- Problem
- Multiple ring artifacts reported on CT image

- Troubleshooting steps
- CT Service completed a physical inspection of CT detector for contrast spill on surface of detector
- A CT phantom scan confirmed that ring artifacts were reproducible at lower kV settings (80/100kV)
- Water/Air calibrations were completed
- Service retested phantom scans and artifacts were still visible.
 - Calibration did not remove ring artifacts
- Service replaced QV detector control boards (converts charge to reference voltage) and retested phantom scans
 - Replacing QV boards did not remove ring artifacts

- Problem Resolution
- CT Service contacted Canon to confirm possible detector fault
- Canon confirmed after analysis that CT detector was faulty and causing ring artifacts on low kV settings (80/100kV)
- CT Service/Canon replace CT detector and completed full Water/Air calibrations. Service retested phantom scans and ring artifacts were eliminated.
